This program will address the most common system problems associated with the A&E Patio Awnings supplied by The Dometic Corporation. Our intent is to provide you with a guideline of checks to make, should you encounter one of the following symptoms.

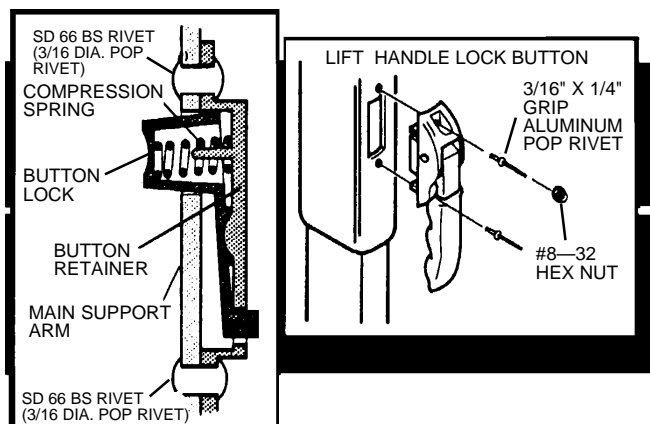
### 1.3 PUSH BUTTON ASSEMBLY

The push button assembly locks the main support arm to the adjustable arm assembly and controls the height of the awning in the open position. To check it, open the awning to full extension. Look inside the main support arm, and activate the push button to see if the locking pin is moving in and out of the hole in the adjustable arm assembly. If the locking pin does not move, or has been

broken off, the push button assembly must be replaced. At times the lock pin of the push button assembly can break off and jam between the push button housing and the adjustable arm assembly, making it difficult to extend the main support arm.

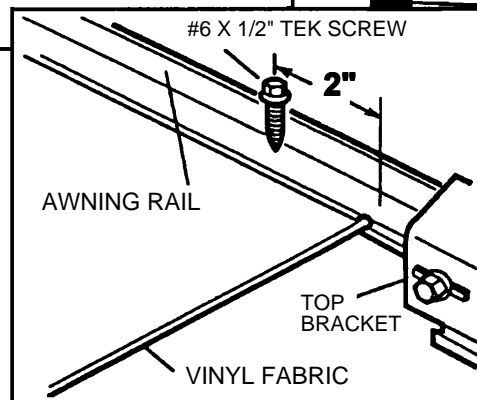
### 2.1 POSITION

For the awning to operate properly the fabric must be positioned properly in the awning rail and on the roller tube.

Open the awning and check the position of the fabric between the top mounting brackets. If the fabric is not centered, remove the tek screws, center it, and replace the screws.

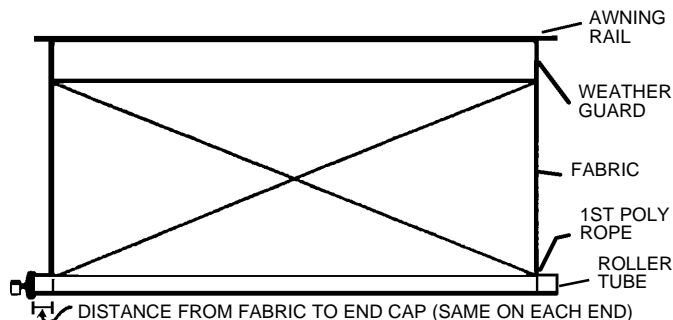
### 2.2 SQUARE

To check fabric for square, measure from the top right hand corner of the fabric (not the weatherguard) to the bottom left hand corner at the poly rope. Now measure from the top left hand corner to the bottom right hand corner as shown below.

In this check, the difference of the two dimensions should be no more than one inch. If it is more, the fabric is out of square, and replacement would be necessary.

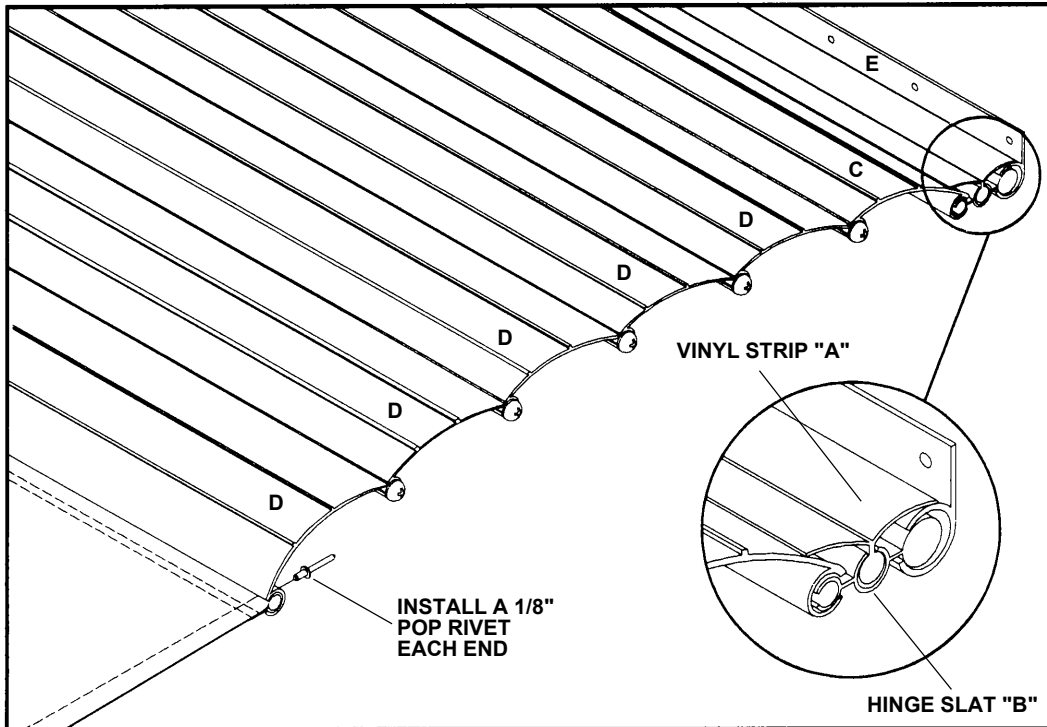
**9000 WITH HINGE SLAT**

- A - VINYL STRIP**
- B - HINGE SLAT**
- C - TOP SLAT**
- D - MAIN SLAT**
- E - AWNING RAIL**

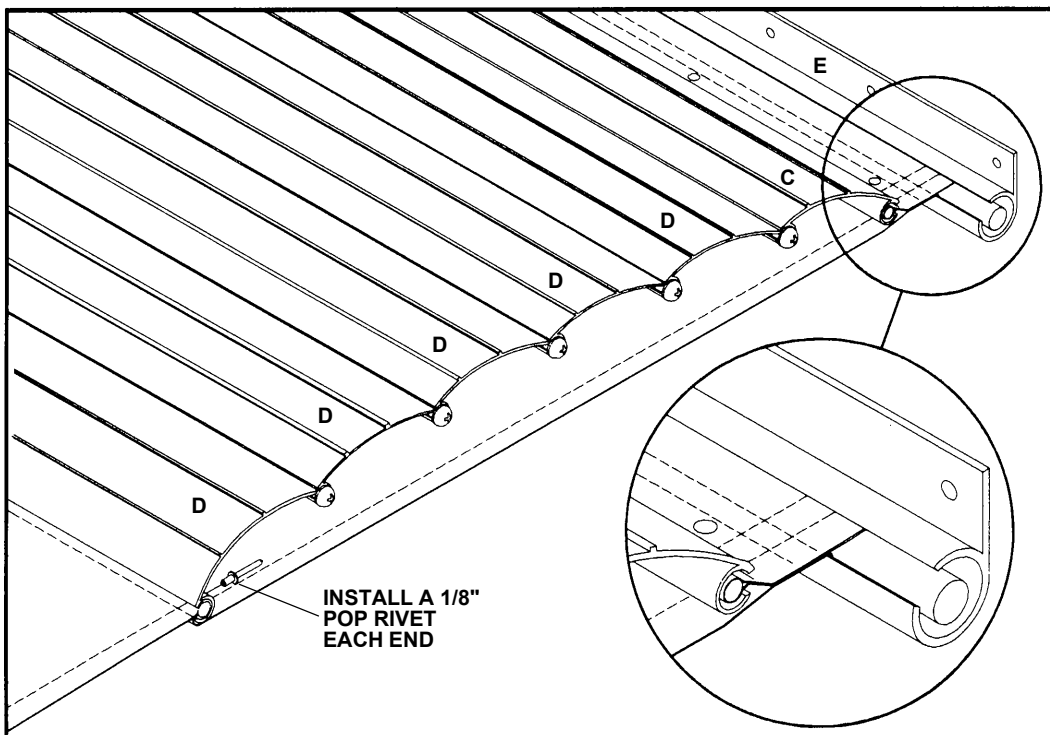
**9000 AND 9500 WITHOUT HINGE SLAT**

**TOP SLAT "C"**  
VIEW RH END

**MAIN SLAT "D"**  
VIEW RH END

**HINGE SLAT "B"**

**VINYL STRIP "A"**

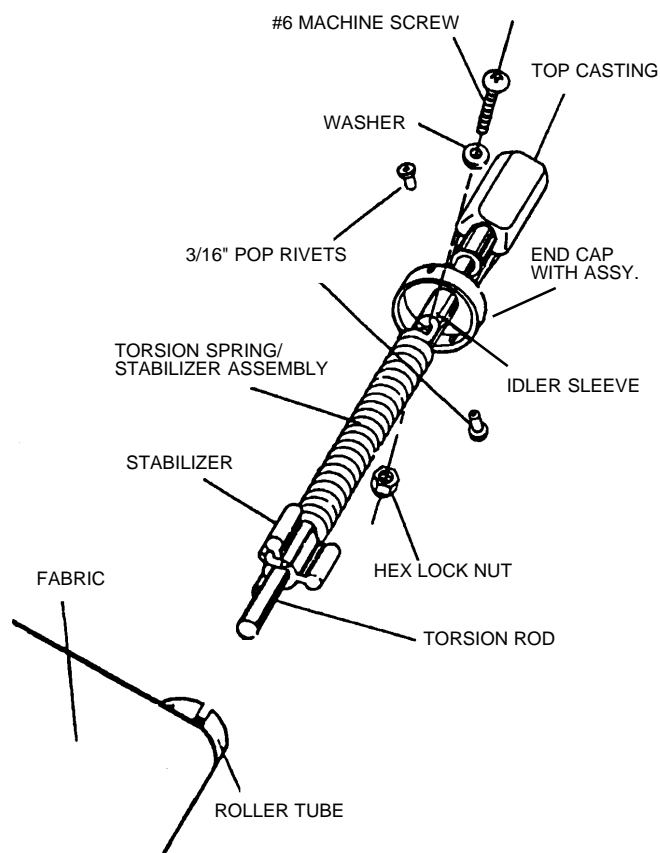
When difficulties are experienced in rolling the awning up, the tension on the torsion should be checked. In

most cases adding a few turns of torque to each end will correct the problem. If all tension has been lost, refer to the following chart and apply the specified number of turns as indicated. This must be done with the awning extended two feet away from the coach.

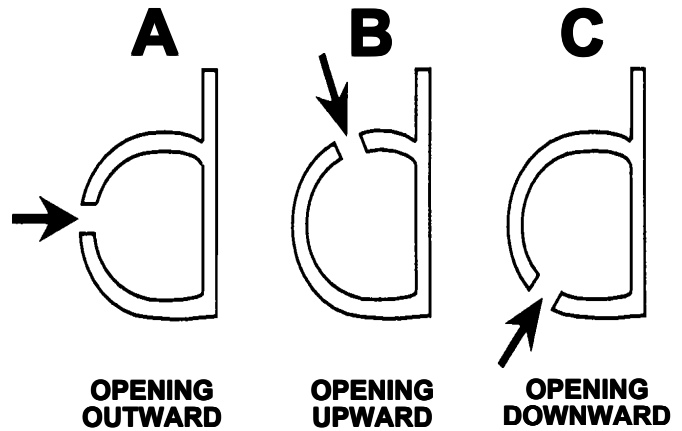
### **4.3 TYPE**

There are three types of awning rail used in the RV industry. Of these, type A and B (see below) are acceptable for use on the 9000 Series awning that utilizes a hinge slat (see Sec.2.5) . Type C should never be used on the 9000 Series that utilizes a hinge slat (see Sec. 2.5) as it could cause a binding problem on the aluminum guard assembly, but it is acceptable on the vinyl awnings.
